**Flood Control Project Maintenance
Levee Inspections**
LMA District Cover Sheet
Spring 2019 Levee Inspection Results

Reclamation District No. 0070 Meridian

Spring 2019 Levee Inspection Results

Waterway			Bank	Unit Miles
Unit No. 01 Sutter Bypass			Right	7.92
	Spring (March - May)	Summer (June - August)	(September - November) Fall	Winter (December - February)
Unit Maintenance Rating (Fall Only)				
Date of Inspection	4/2/2019 - 4/2/2019			
DWR Inspector	Makar Sokol			
Accompanied By	Andy Duffey			
	Mike Engelmann

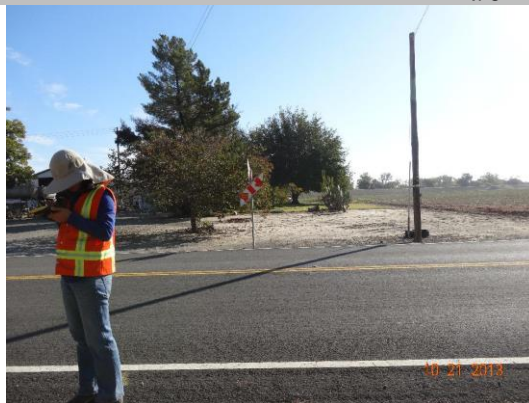
Photo 1 of 3 : UCIP_SP_2019_23384_40249.jpg

Comment Code					
Inspector Comment					
FS_ID:23384 DS_ID:21415 EP_NO: 15936 Repair Type: Non-Urgent Crossing Status: Indicator Found UCIP Comments: No markers visible on levee slope or levee toe to indicate line crosses levee. Need to contact PG&E to confirm location through levee. Also need to confirm the emergency contact person for this crossing. FIELD_STRUCT_DESC: 8-inch steel natural gas pipeline through the levee, 2.5 feet below the crown. Gas line markers on the landside (LS). (Plans to remove an existing 16-inch pipe and install an 8-inch natural gas pipe to existing pipe within the 10-foot LS limits of the levee authorized under Permit No. 15936, 1992 - Pacific Gas and Electric Company [PG&E]). FS Date: 10/21/2013

View of markers on the east side of S. Tarke Road.

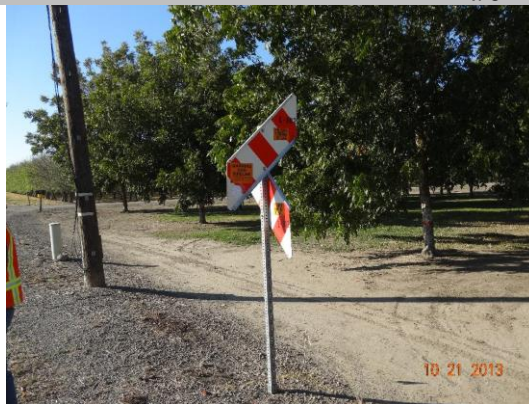
Photo 2 of 3 : UCIP_SP_2019_23384_40247.jpg

View of markers on the west side of S. Tarke Road.

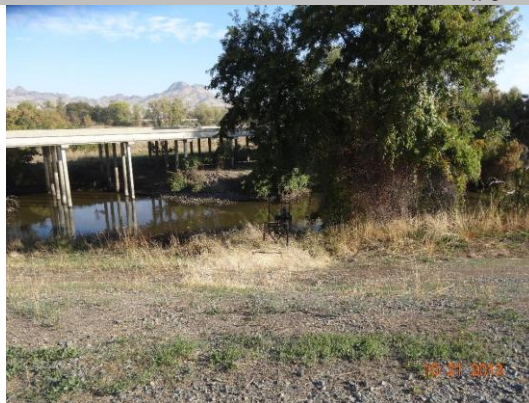
Photo 3 of 3 : UCIP_SP_2019_23503_40785.jpg

Comment Code						
Inspector Comment						
FS_ID:23503 DS_ID:21351 EP_NO: 3686 Repair Type: Non-Urgent Crossing Status: Found UCIP Comments: Dense vegetation limits the inspector's visibility to identify signs of pipe failure (leaks) along the waterward slope. Recommend removing vegetation along pipe alignment to conduct proper inspection of structure and appurtenances. Unable to find the gate valve on landward side. Walkway on waterward side in bad shape. This crossing is referenced in the USACE Periodic Inspection as item USACE_CESPK_MRD1_2012_p_0300 for 18 inch pipe. Pipe on LS is 10 inch not 18 inch. SEE UCIP DS_ID 21350 for details pertaining to 18 inch pipe. FIELD_STRUCT_DESC: 10-inch irrigation discharge pipe of an unknown material through the levee, 14.8 feet below the crown. Electrical conduit through the levee, 1 foot below the crown. Pump on a pile structure in the stream. Service pole with meter and control panel at the landside (LS) toe. Slide gate with walkway on the waterside (WS) end. Gate valve on the LS end, not found during 10/21/2013 pipe inventory. Rock revetment on the WS slope. (Plans for removal of a pump on the LS and installation of a pump and two concrete piers on the WS authorized under Permit No. 3686, 1961 - Gerald A. Frye). [Additional Reference(s): DWR Levee Log, 2007]. FS Date: 10/21/2013

View of waterward side--dense vegetation along slope.

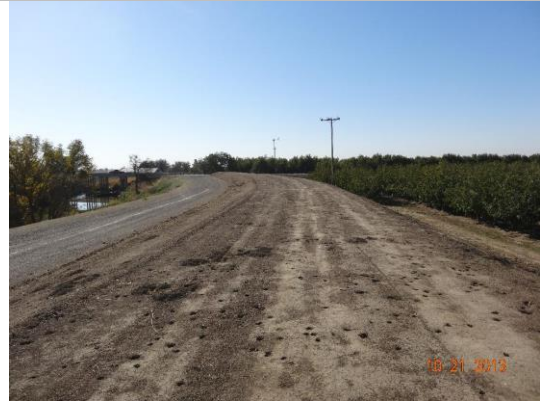
Photo 3 of 3 : UCIP_SP_2019_23526_40940.jpg

Comment Code					
Inspector Comment					
FS_ID:23526 DS_ID:21355 EP_NO: 9961 Repair Type: Non-Urgent Crossing Status: Found UCIP Comments: Dense burrow activity present on both waterward side and landward side. Recommend addressing burrow activity at this location. Also recommend having owner clear vegetation blocking access along walkway. This crossing is referenced in the USACE Periodic Inspection as item USACE_CESPK_MRD1_2012_p_290. FIELD_STRUCT_DESC: 10-inch (not 12-inch as referenced in the permit) steel irrigation discharge pipe through the levee, 5.4 feet below the crown. Siphon breaker in a corrugated metal pipe (CMP) riser on the landside (LS) slope. 24-inch concrete standpipe at the LS toe. Walkway to the pump on a pile structure in the stream. (Retention of a 12-inch steel irrigation pipe through the levee, 5.4 feet below the crown, a walkway to the pump on a pile structure in the stream, and a siphon breaker in a CMP riser on the landward slope authorized under Automatic Board Order (ABO) issued as Permit No. 9961, 1974 - Louis Tarke, Trustee). [Additional Reference(s): DWR Levee Log, 2007]. FS Date: 10/21/2013

View of levee crown and waterward berm looking upstream from crossing.

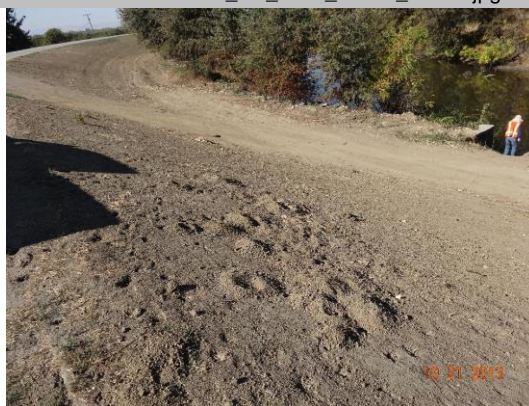
Photo 2 of 3 : UCIP_SP_2019_23506_40801.jpg

Recent burrow activity soil months next to holes.

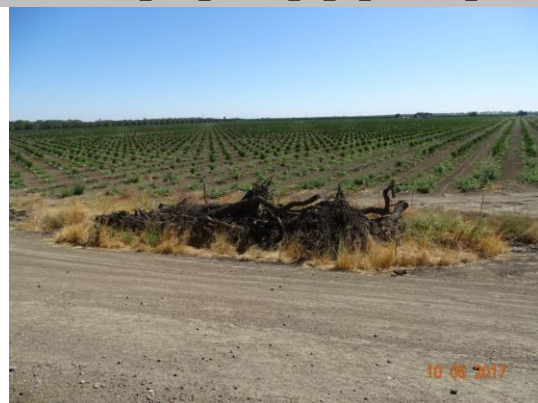
Photo 1 of 1 : SP_2019_RD0070_29_38_20190326_00016.jpg

View of the tree limbs along the landside toe.

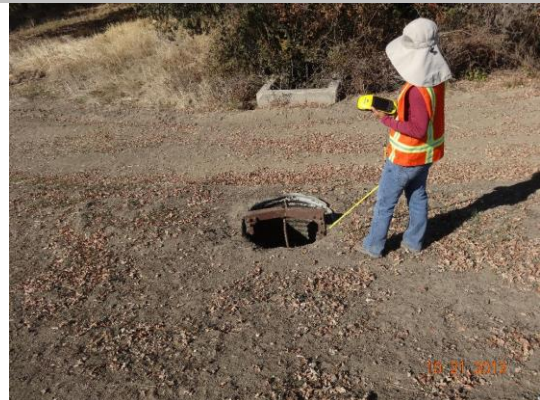
Photo 2 of 3 : UCIP_SP_2019_23529_40963.jpg

CMP riser with screw gate inside. Gate is missing the handle to close gate.

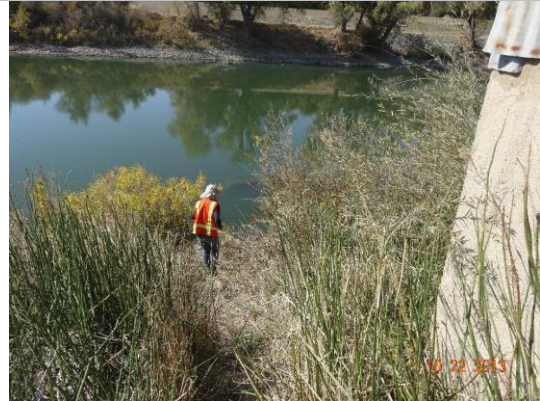
Photo 3 of 3 : UCIP_SP_2019_23891_41837.jpg

Dense vegetation covers pipe intake on waterward side.

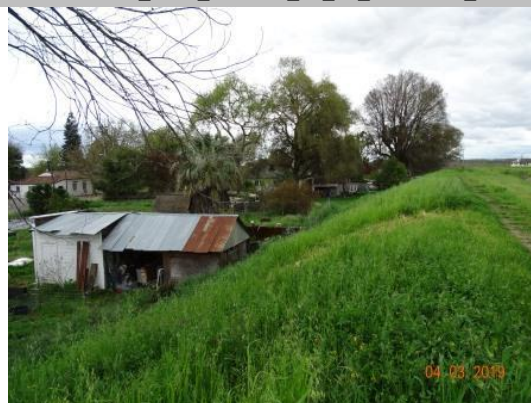
Photo 1 of 1 : SP_2019_RD0070_30_92_20190408_00132.jpg

View of the unpermitted outbuilding at the landside toe. Spring 2019.

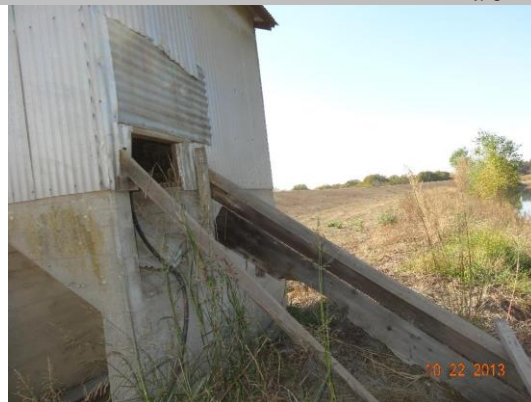
Photo 2 of 3 : UCIP_SP_2019_23964_42116.jpg

No pipe exists the pump house on waterward side.

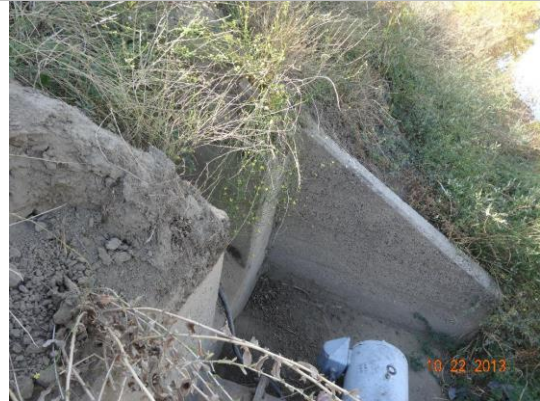
Photo 3 of 3 : UCIP_SP_2019_23964_42113.jpg

Crossing appears altered on waterward side.

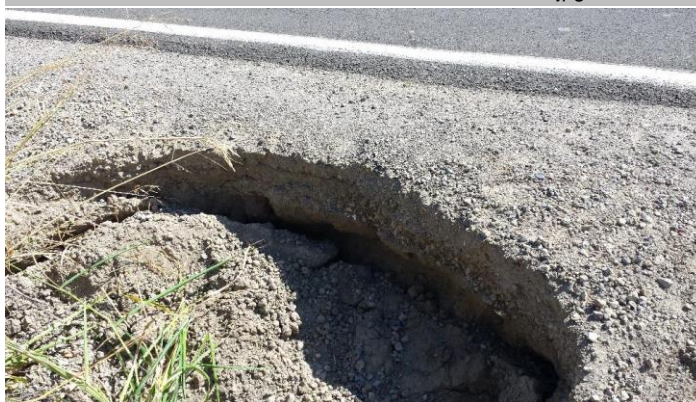
Photo 3 of 3 : UCIP_SP_2019_50007_74614.jpg

Slope damage within 2 feet of County Road.

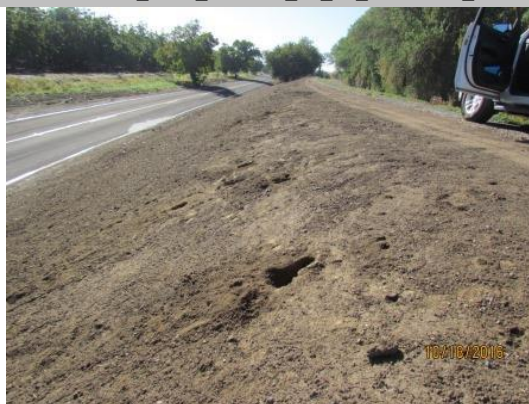
Photo 1 of 1 : SP_2019_RD0070_30_61_20190326_00009.jpg

View of the rodent holes along the landside slope.

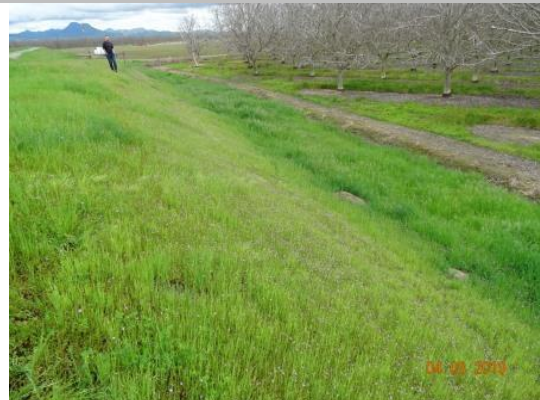
Photo 1 of 1 : SP_2019_RD0070_30_78_20190408_00124.jpg

View of the rodent burrows on the landside slope and toe. Spring 2019.

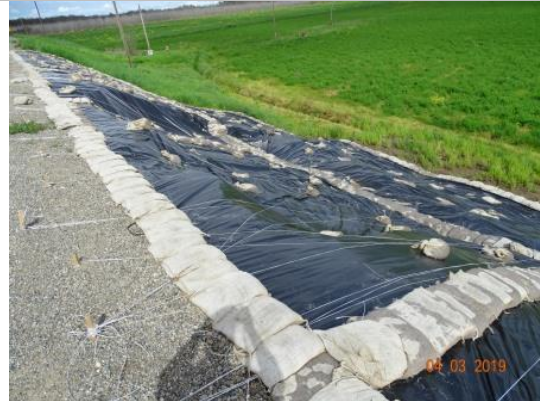
Photo 2 of 2 : SP_2019_RD0070_30_66_20190408_00118.jpg

View of the temporary solution used to address the sloughing. April 3, 2019.
